ROCKY FLATS ENVIRONMENTAL  
TECHNOLOGY SITE

FISCAL YEARS 2002 and 2003  
STEWARDSHIP SUMMARY

Rocky Flats Environmental Technology Site  
10808 Highway 93  
Golden, CO 80403-8200

September 30, 2003

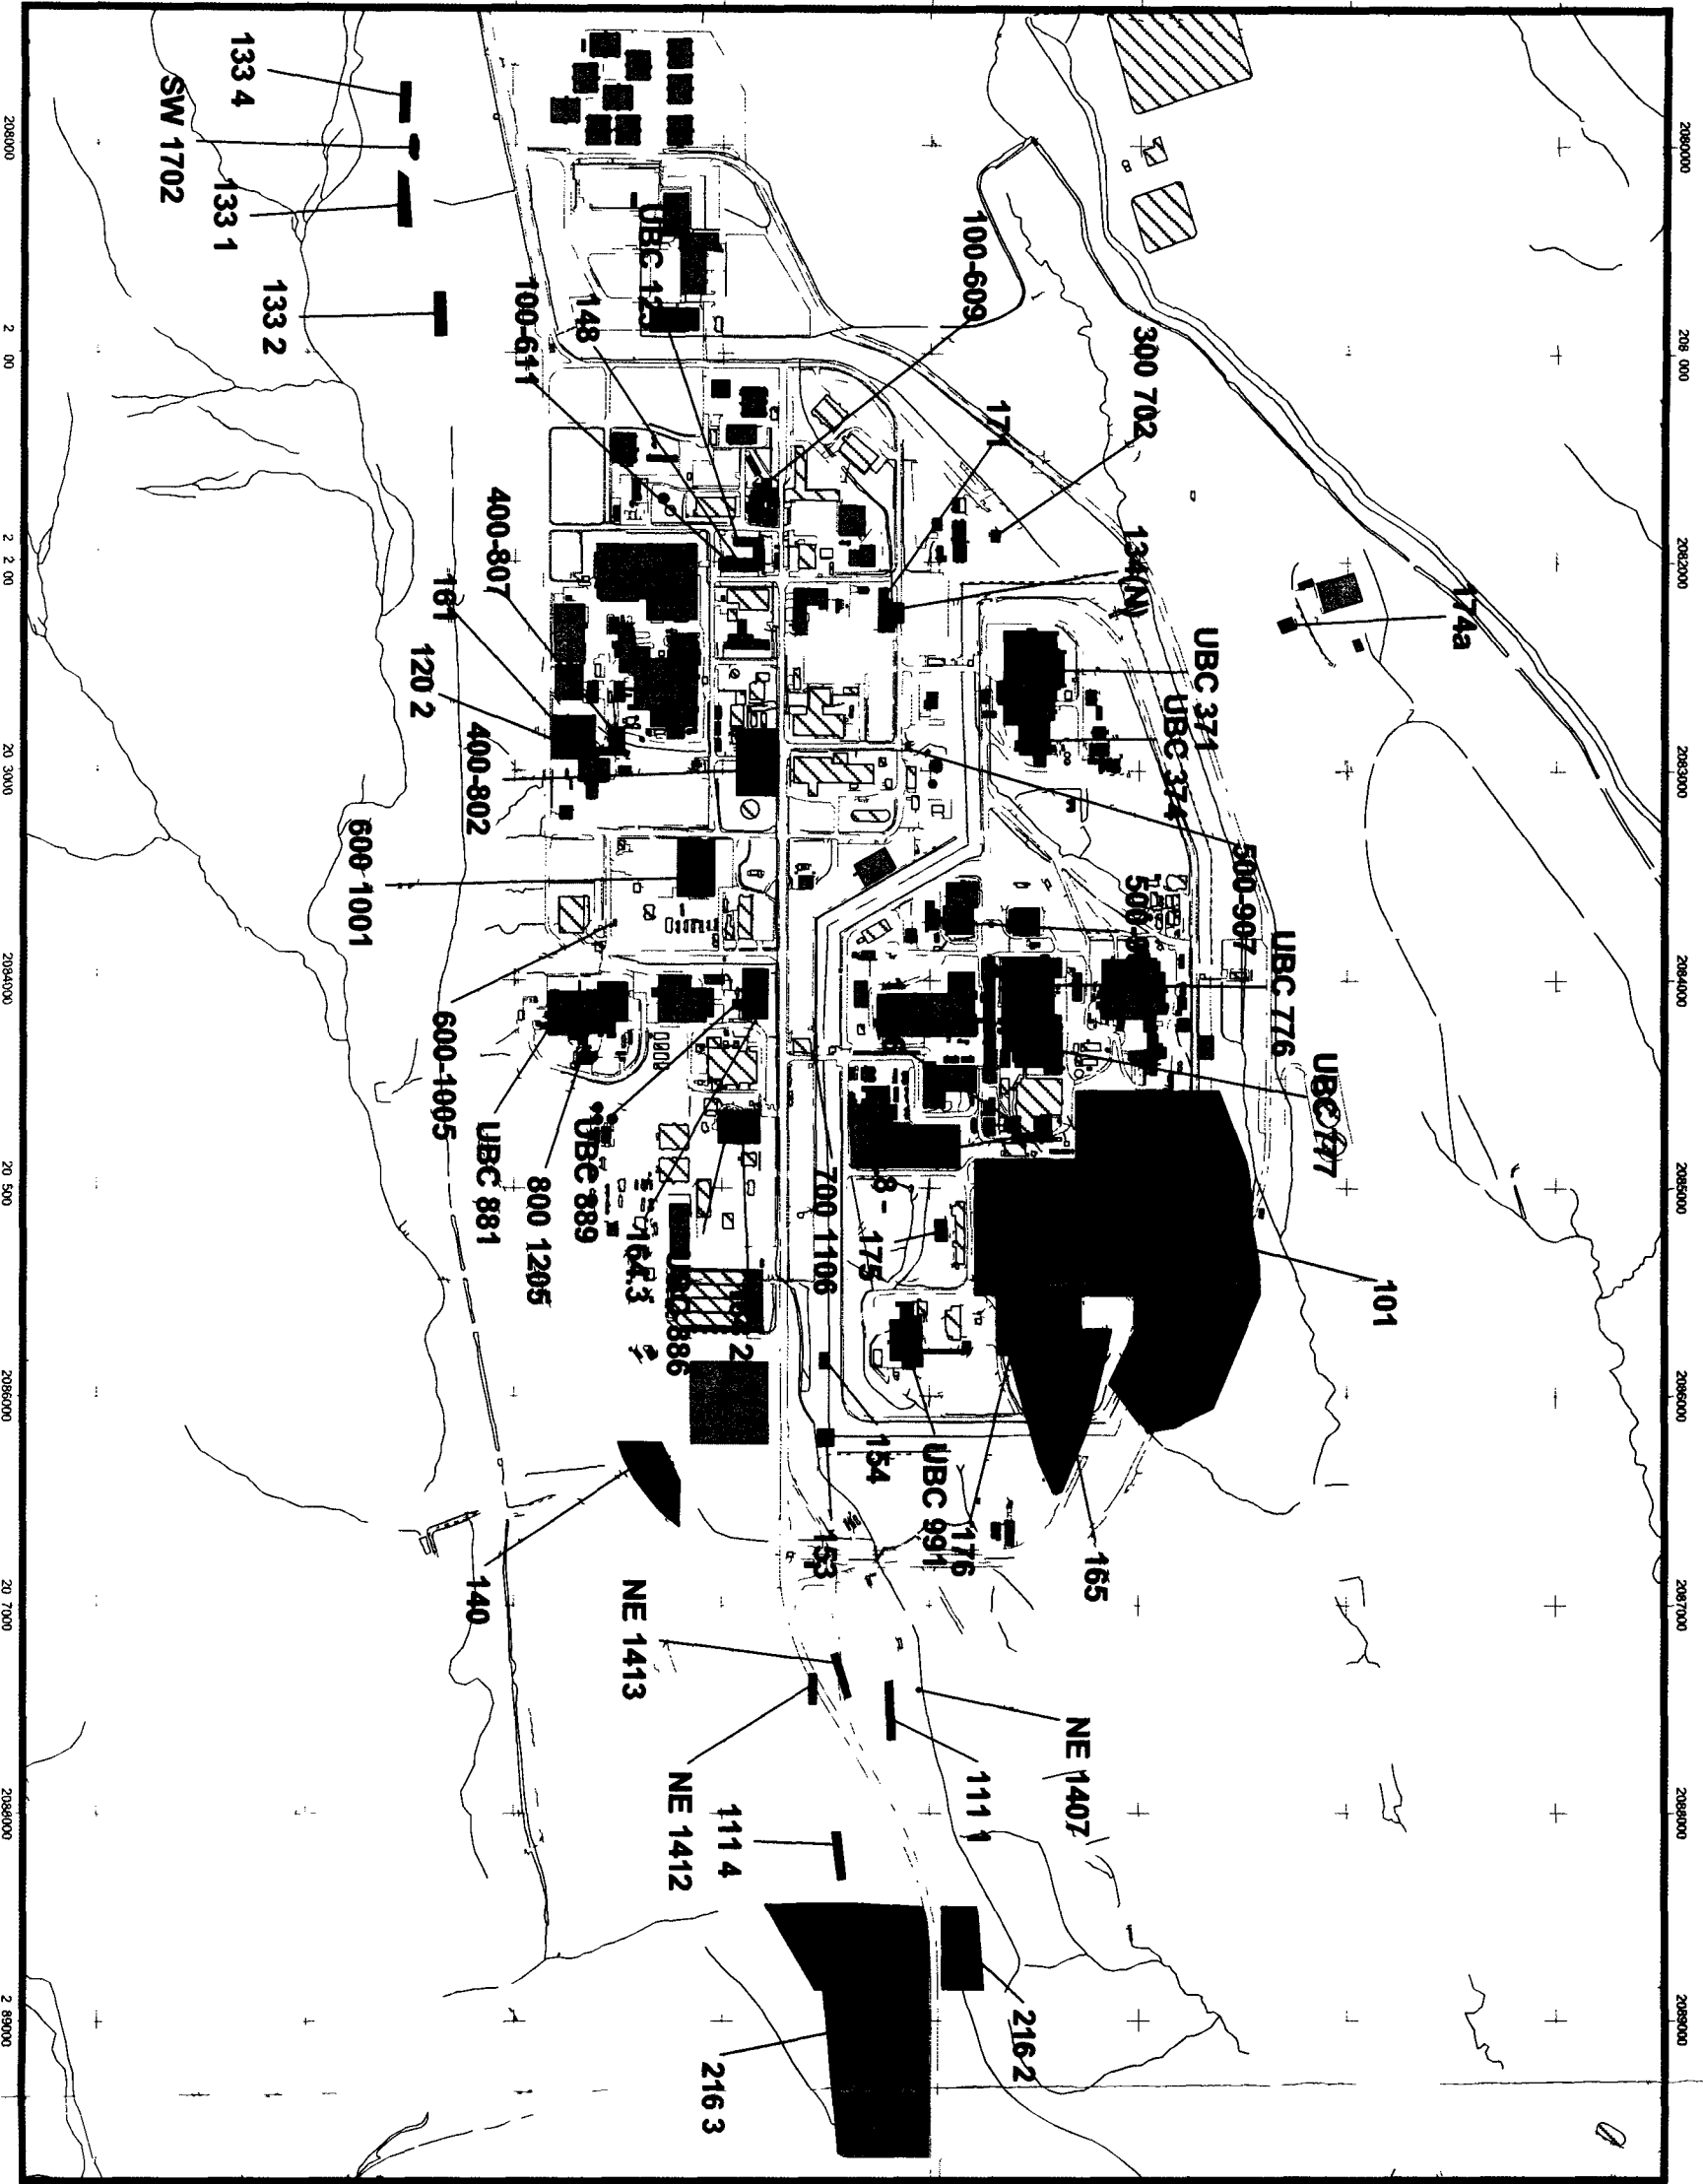
## FY02/03 IHSS Characterizations/Evaluations and Accelerated Actions

In FY02/03, numerous IHSS Groups were characterized, and in some cases, the IHSSs were remediated through an accelerated action (Figure 4-1 and Table 4-1). Several IHSSs were also evaluated for NFAA based on historical data (see footnote 1 to Table 4-1). The IHSS groups investigated were characterized in accordance with the IA and BZ Sampling and Analysis Plans (SAPs) (DOE 2000 and 2002b). Accelerated actions occurred at nine IHSS Groups in FY 02 and 03 in accordance with the ER RSOP. Summaries of the accelerated actions are provided in Table 4-2. Accelerated actions included soil, building slab, building footers, drains, and underground utilities removal, as well as removal of tanks and pipelines associated with the Original Process Waste Lines (OPWLs) (IHSS 000-121). Accelerated actions at four of the nine IHSS Groups included removal of OPWLs.
